**CALIFORNIA DIVISION OF MINES AND GEOLOGY
FAULT EVALUATION REPORT FER-224
GILLEM, BIG CRACK, AND RELATED FAULTS
WESTERN MODOC, AND EASTERN SISKIYOU COUNTIES, CALIFORNIA**

**William A. Bryant
Associate Geologist
November 20, 1990
(Revised March 14, 1991)**

**Division of Mines and Geology
630 Bercut Drive
Sacramento, CA 95814**

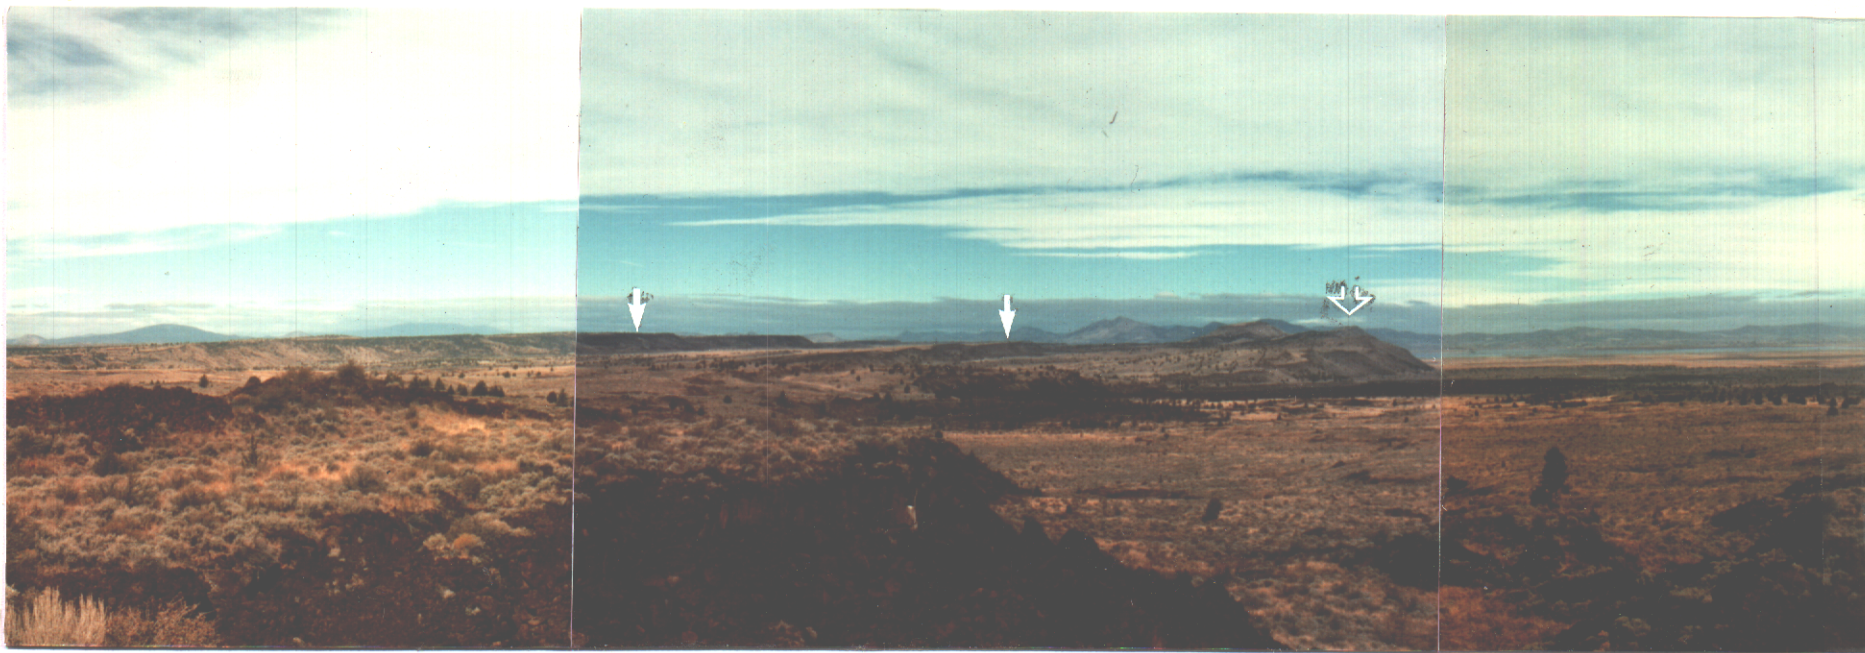
Photo 1 (to FER-224). The Gillem fault is delineated by the prominent east-facing scarp in the background (open arrow); view north. Additional east-facing scarps (arrows) delineate the Fleener Place (west of the Gillem fault) and Crumes Lake faults. The basalt of Mammoth Crater, a late Pleistocene flow that is found throughout Lava Beds National Monument, crops out in the foreground.

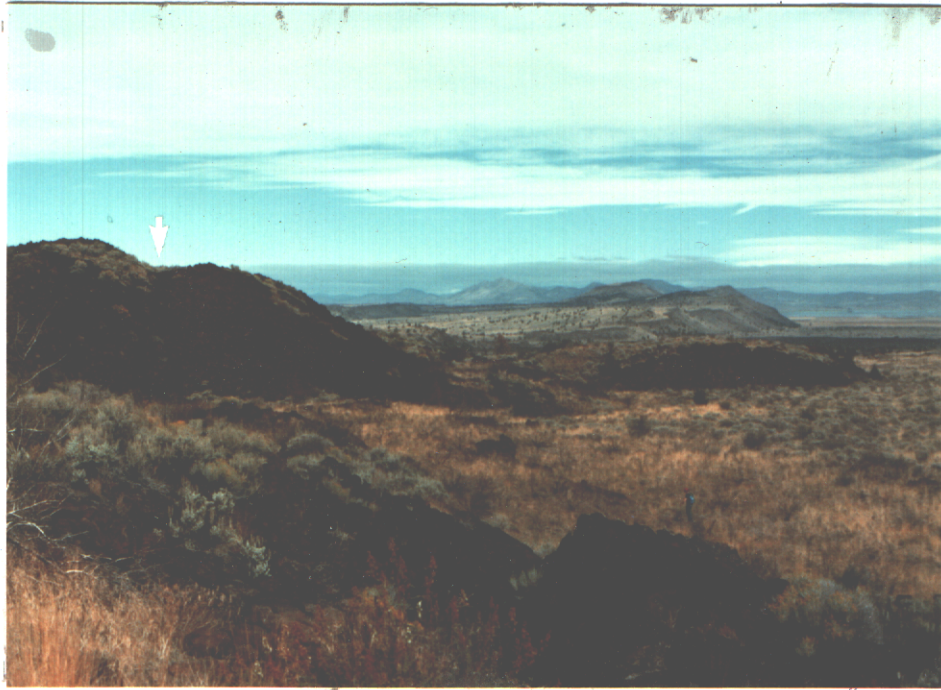
Photo 2 (to FER-224). A 5-meter high, east-facing scarp in late Pleistocene basalt of Mammoth Crater delineates the southern Gillem fault (foreground); view north. A younger flow unit within the basalt of Mammoth Crater flowed across this scarp. The Gillem fault is expressed in this younger flow unit principally by a linear trough (arrow) that aligns with fissures near the top of the 5-meter high scarp both north and south of the flow unit.

A younger flow unit within the late Pleistocene Mammoth Crater Basalt flowed across an approximately 5 m high scarp at locality 4, based on field observations by this writer (Figure 2b; Photo 2). The predominant sense of displacement is extension and is delineated by well-defined troughs. Vertical displacement of the younger flow unit is minimal across the Gillem fault. These well-defined troughs developed in very blocky basalt. It is not clear how young the rubble is within troughs. The troughs in the younger flow unit align with fissures along the principal trace of the Gillem fault to the north and south. However, unfilled fissures are not common along most of trace of the Gillem fault (Figures 2a and 2b).
